Fatigue Behaviour of Aluminium Alloy

Bachelor of Technology
in
Metallurgical & Materials Engineering

Department of Metallurgical & Materials Engineering
National Institute of Technology
Rourkela
2007

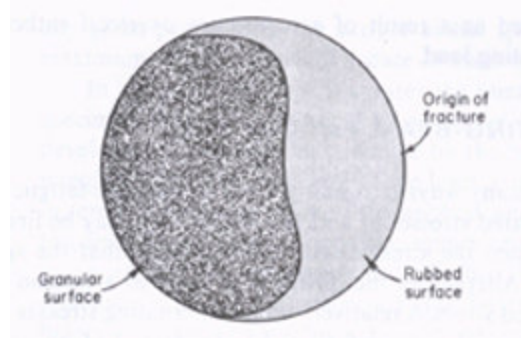
Figure-1.1

Notice that the rough surface indicates brittle failure, while the smooth surface represents crack propagation

One can determine that a material failed by fatigue by examining the fracture sight. A fatigue fracture will have two distinct regions; One being smooth or burnished as a result of the rubbing of the bottom and top of the crack. These visual clues may be seen in figure-1

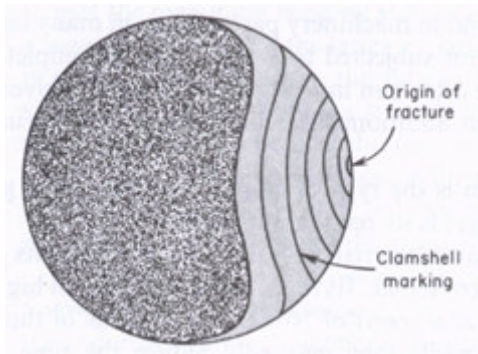
Figure 1.2

An example of beachmarks or "clamshell pattern" associated with stress cycles that vary in magnitude and time as in factory machinery

Other features of a fatigue fracture are beach marks and striations. Beachmarks, or clamshell marks, may be seen in fatigue failures of materials that are used for a period of time, allowed to rest for an equivalent time period and the loaded again as in factory usage. Striations are thought to be steps in crack propagation, where the distance depends on the stress range. Beachmarks may contain thousands of striations. Visual Examples of Beachmarks and Striations are seen below in Fig. 1 and 2:

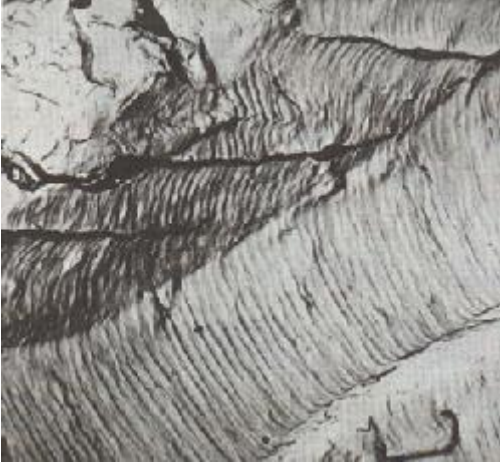
Figure 1.3

An example of the striations found in fatigue fracture. Each striation is thought to be the advancement of the crack. There may be thousands of striations in a beachmark.

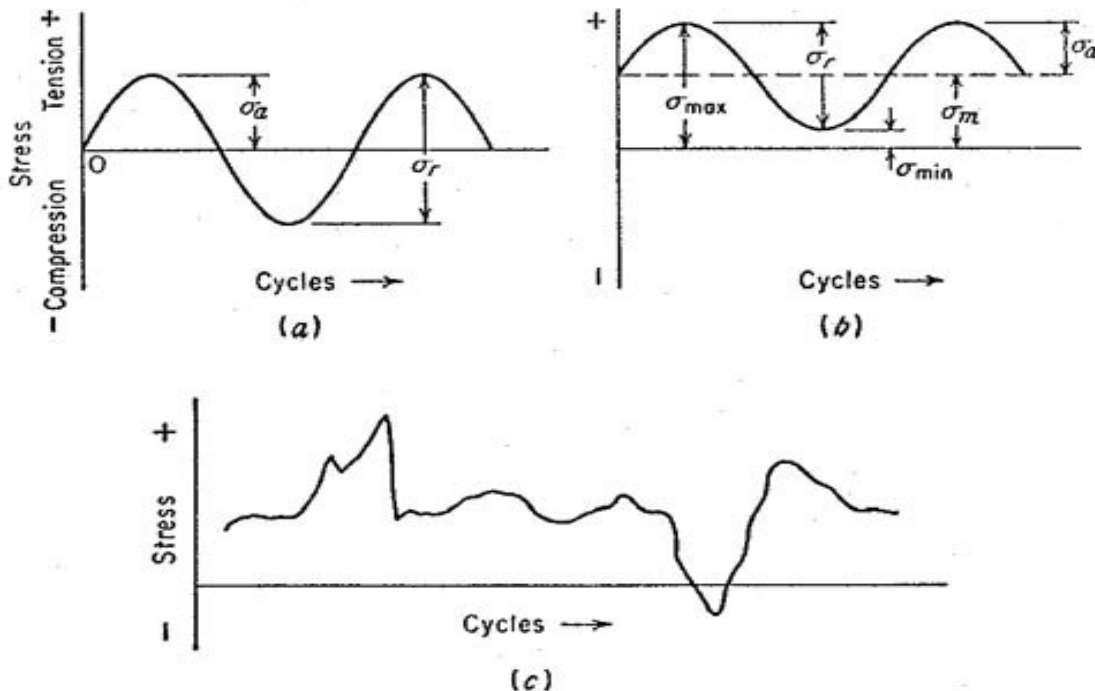
Figure 2.1 Typical fatigue stress cycles. (a) Reversed stress; (b) repeated stress; (c) irregular or random stress cycle.

At the outset it will be advantageous to define briefly the general types of fluctuating stresses which can cause fatigue. Figure 4 serves to illustrate typical fatigue stress cycles. Figure 4a illustrates a completely reversed cycle of stress of sinusoidal form. For this type of stress cycle the maximum and minimum stresses are equal. Tensile stress is considered positive, and compressive stress is negative.

Figure 4b illustrates a repeated stress cycle in which the maximum stress σ_{\max} (R_{\max}) and minimum stress σ_{\min} (R_{\min}) are not equal. In this illustration they are both tension, but a repeated stress cycle could just as well contain maximum and minimum stresses of opposite signs or both in compression.

Figure 4c illustrates a complicated stress cycle which might be encountered in a part such as an aircraft wing which is subjected to periodic unpredictable overloads due to gusts.

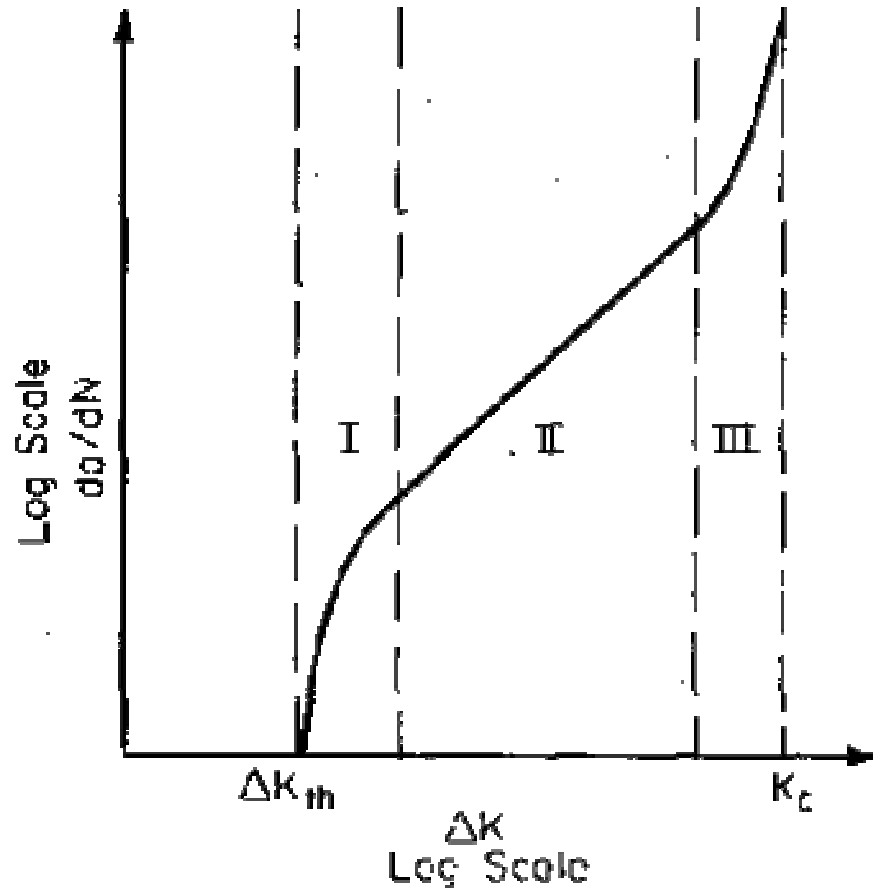
Figure 2.2 Three regions of crack growth rate curve

A plot of $\log da/dN$ versus $\log \Delta K$, a sigmoidal curve, is shown in Fig.5. This curve may be divided into three regions.

At low stress intensities, Region I, cracking behavior is associated with threshold, ΔK_{th} , effects, below which no observable crack growth occur. At stresses below cracks behaves as non propagating cracks. this occurs at a crack growth rate of .25 mm/cycles or less.

In this region the slope of the $\log da/dN$ versus $\log \Delta K$ curve is approximately linear and lies roughly between 10^{-6} and 10^{-3} in/cycle. Many curve fits to this region have been suggested. The Paris equation, which was proposed in the early 1960s, is the most widely accepted. In this equation

Finally, in the Region III, at high ΔK values, crack growth rates are extremely high and little fatigue life is involved. The values here approach to fracture toughness of the material.

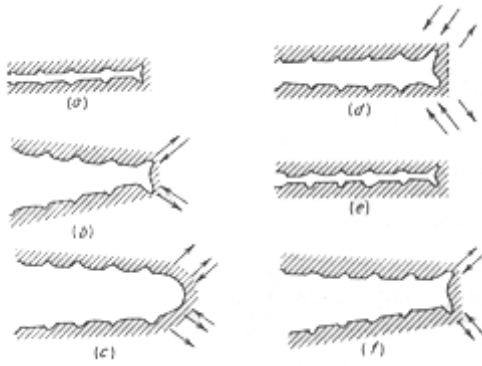
Figure-2.5. Plastic blunting process for growth of stage II fatigue crack

At the start of the loading cycle the crack tip is sharp (Fig. 8 a). As the tensile load is applied the small double notch at the crack tip concentrates the slip along planes at 45° to the plane of the crack (Fig. 8 b). As the crack widens to its maximum extension (Fig. 8 c) it grows longer by plastic shearing and at the same time its tip becomes blunter. When the load is changed to compression the slip direction in the end zones is reversed. The crack faces are crushed together and the new crack surface created in tension is forced into the plane of the crack (Fig. 2.5).

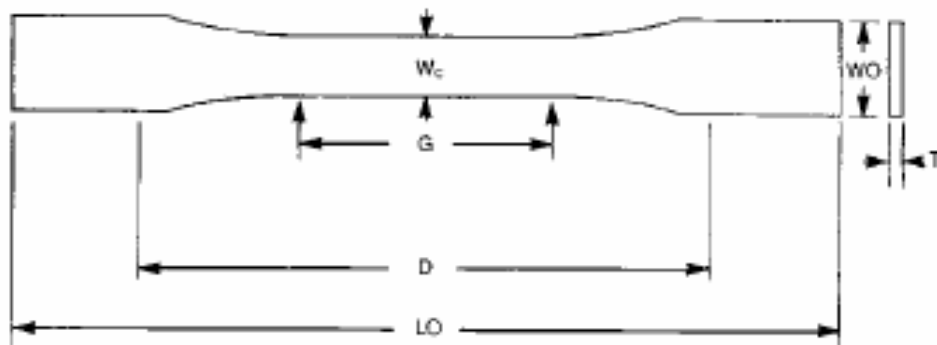
Figure-3.1

1. A specimen sheet was taken of the size 1 feet X 170 mm. It was cut into the size so as to make 2 tensile specimens and 2 fatigue specimen of size,

Length= 100 mm

Thickness= 6 mm

Breadth= 10 mm

Gauge length= 25 mm

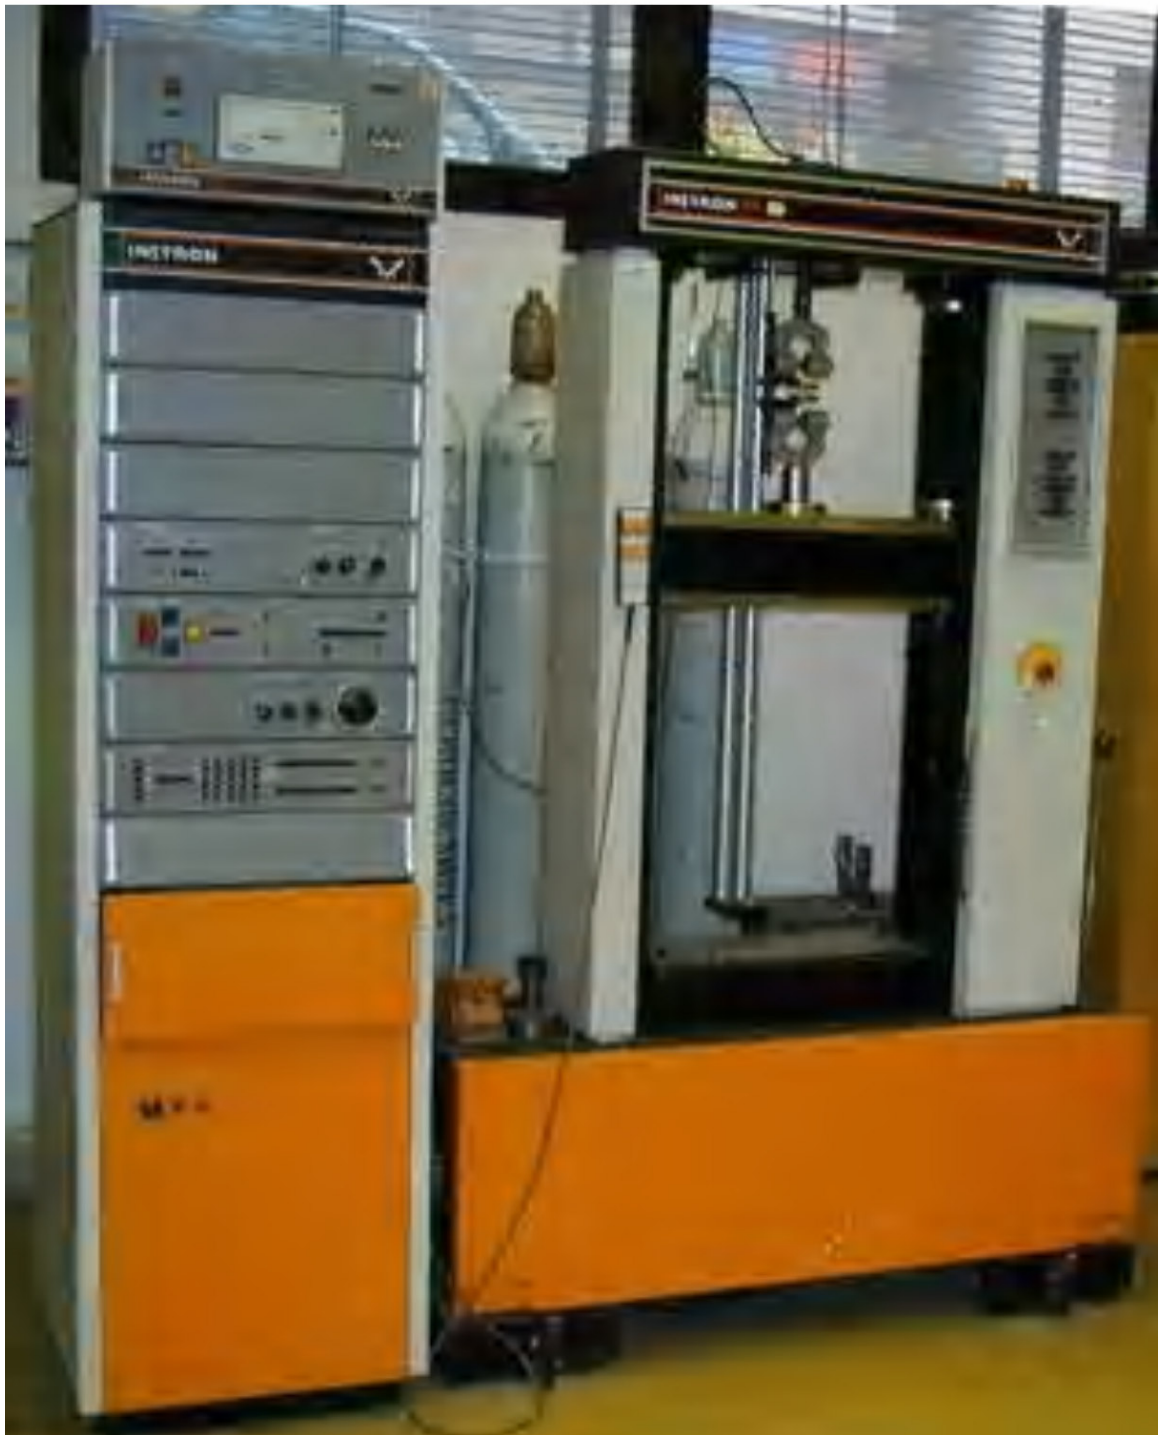
Figure-3.3 Instron 1195

This was done so as to get the specimen tensile strength. This test was done in INSTRON 1195. From this obtained data the fatigue test was done. Yield strength of the sample is obtained from this machine. Other related data are also obtained.

- applications: tensile, compression and bending tests in a temperature range from – 196 to 1600°C ;
- type: mechanical tensile strength tester;
- max. force: 100 kN tensile, 50 kN compression;
- speed: 0.05 tot 50 mm/min ;

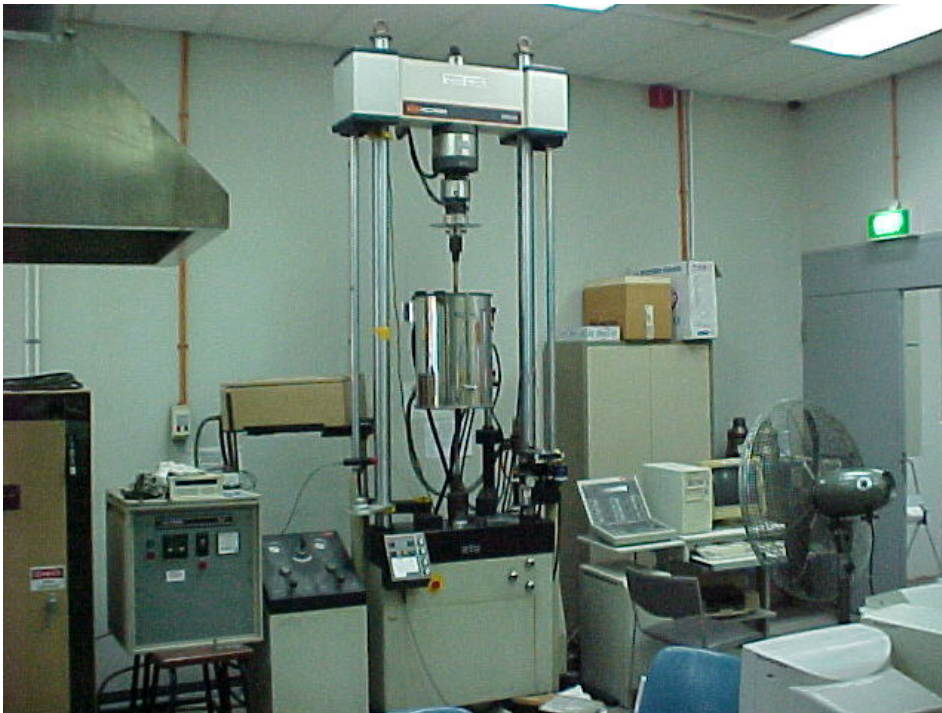
Figure-3.4 INSTRON 8502

After the calculation of yield stress is done, the specimen then would be treated in INSTRON 8502 .In this fatigue life of the material is known. In this machine number of cycles leading to failure of the material is known which gives the fatigue strength. This is a Electro-magnetic resonance machine capable of 50kN dynamic and 100kN static loading. Fitted with a DCPD system with PC based data acquisition. In this test the fatigue life of the specimen was determined at two different temperatures one above the recrystallisation range other below this temperature in recovery range. This recrystallisation temperature for aluminum alloy was found to be 0.5 t_m . Melting temperature of Aluminium found to be 667 so recrystallisation temperature was found to be 200.

In this machine the fatigue life of the specimen is calculated. The load applied here is 90% of the yield stress of the material.
